Guided Wave Testing Case Study 4 Inspection of Pipelines at Soil to Air Interface

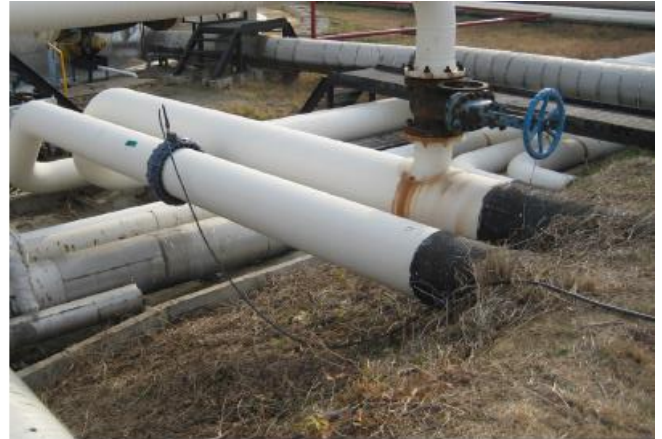
An overview of the pipe at the earth penetration

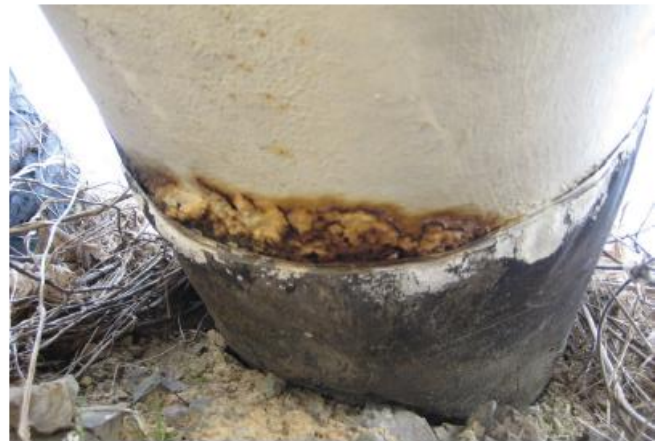
- Soil/air interface and buried section inspected
- Medium (Category 2) corrosion identified at the entrance location
- Defect axial position and circumferential orientation highlighted for follow up and repair

Corrosion patch detected at the entrance location.
