Guided Wave Testing Case Study 7 Defects in Elbows

- 16" Crude Oil line
- Tight 1D elbows

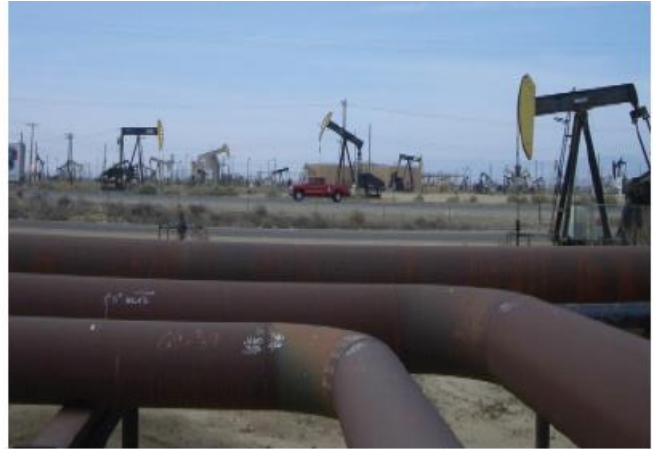
A view of the inner radius of the 1D elbow.

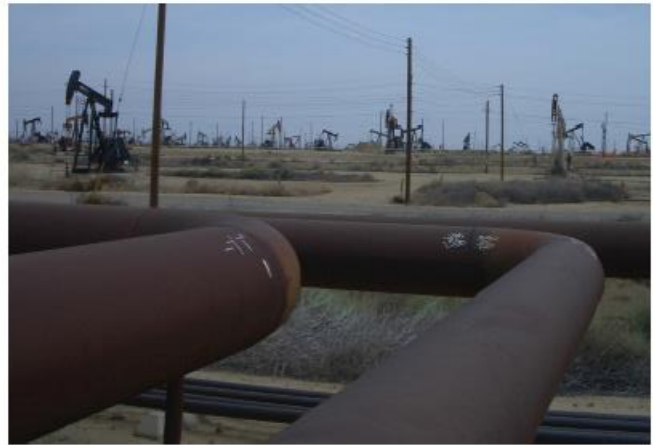
- Defect located in one of the two elbows within the test range.
- The defect is circumferentially aligned with the outer radius where the erosion type defects are commonly found.
- UT confirms the elbow defect has a 65% wall loss.

A view of the outer radius of the 1D elbow.
