## Using Laser Scanning Creatively in a Plant Environment

**Cameron Sjerve, P.Eng.,** *Operations Manager at IRISNDT*

**JANUARY | FEBRUARY 2024**

# Using Laser Scanning Creatively in a Plant Environment

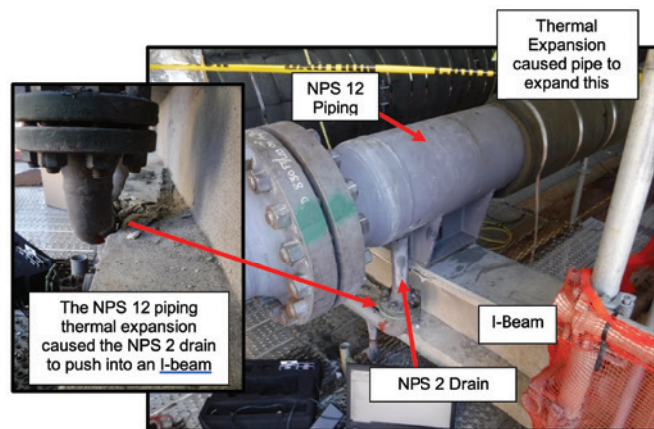
When a newly commissioned plant was started for the first time, an NPS 12 pipe expanded, pushing an NPS 2 drain into an I-Beam (see **Figure 1**). An operator noted that the NPS 2 drain had deflected, so operations immediately shut down the plant to investigate further. One question was whether the NPS 12 and NPS 2 pipes were plastically or elastically deformed. In other words, how prone were they to fail? Based on this information, the mitigation and redesign had to be assessed.

**Figure 1.** Deformed NPS 2 drains.

From this data, a repair plan was made, and the NPS 2 drain was repaired. Further measurements were not required after the plant continued to operate. The NPS 12 line remained intact without requiring further changes.

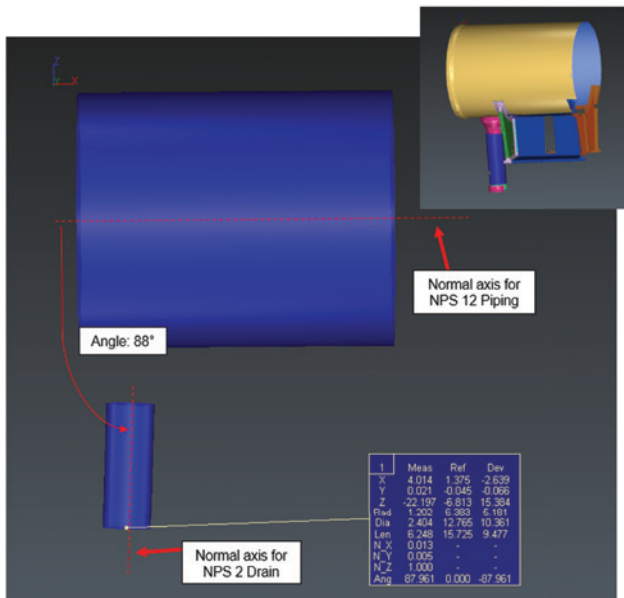
The NPS 12 piping did not appear to have local deformation, such as dents or bulges. The ovality was within the manufacturer's  $\pm 1\%$ OD tolerance based on the measurements extracted from the laser scans. Thus, it had not been deformed. As seen in **Figure 2**, the NPS 2 drain was at an angle of  $\sim 88^\circ$  (instead of  $90^\circ$ ) to the normal axis of the NPS 12 piping. Ideally, one would have a laser scan before the equipment was in operation to compare this result. A prior or baseline scan would provide definitive information regarding how much the NPS 2 drain had deflected from its condition prior to the plant start-up. After talking to the manufacturer and discussing their typical tolerances, it was decided that the NPS 2 drain had plastically deformed. These discussions underline the importance of discussing results with other trades and engineers, as the results from laser scanning can only be put in context once we know typical tolerances.

Figure 2. Laser Scan and Measurements.

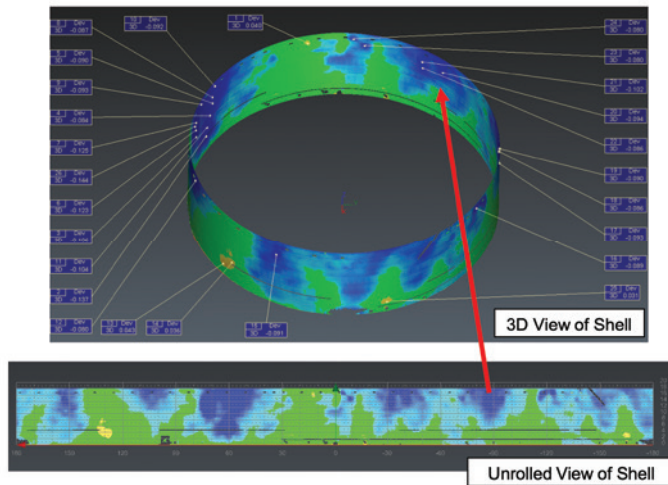
Figure 3. Depressions on the shell of a 215 feet diameter by 60 feet tall tank. The red is on bulges that swell away from the center of the tank, while the blue are depressions towards the center of the tank.

A 215-foot diameter by 60-foot tall tank was scheduled for a routine five-year in-service inspection. During the inspection, the inspector noticed depressions on the upper shell courses. Being well-versed in laser scanning, he asked for an external laser scan assessment of the depressions. The long-range laser scans flagged the depressions as outside API 653 roundness tolerances. See Figure 3.

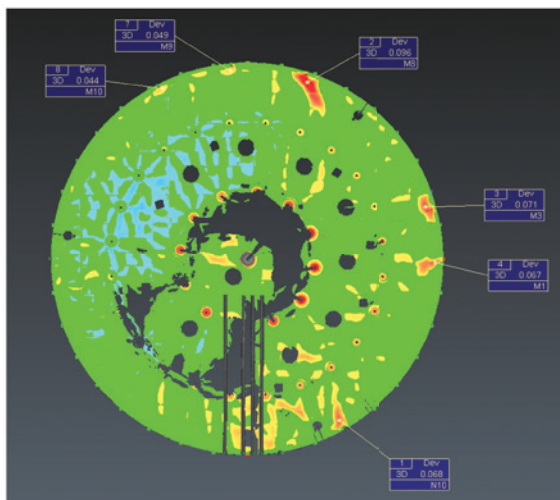
Figure 4. Bulges on the floor of a 215-foot diameter by 60-foot tall tank. The red indicates bulges out of the center, while the blue are depressions into the center.

Often, tank shell deformation initiates with tank floor settlement anomalies. Consequently, after several months, the tank was taken out of service and scanned internally with a long-range laser. The tank had six well-mapped rejectable floor bulges next to its outer diameter. All the bulges were lined up with large nozzles or manways. See Figure 4 and Table 1.

Bulge Identifier	1	4	3	2	7	8
Bulge Radius (ft)	3.13	1.80	3.61	4.59	1.80	1.80
Bulge Height (in)	2.68	2.64	2.80	3.78	1.93	1.73
Permissible Height (in)	1.16	0.67	1.34	1.70	0.67	0.67
% Permissible	231%	394%	209%	222%	288%	258%

The laser 3D model was used to determine the dimensions of the plates required for repairing the tank bulges. The model and discussions with the repair company resulted in a successful repair where the repair plates were fit in through the manway. Ideally, the tank should have been scanned before it was in service—as a baseline. In this case, we compared the floor to what the drawing indicated: a 1/100 sloped floor. Nevertheless, the post-damage scan facilitated the tank's repair and maintenance.

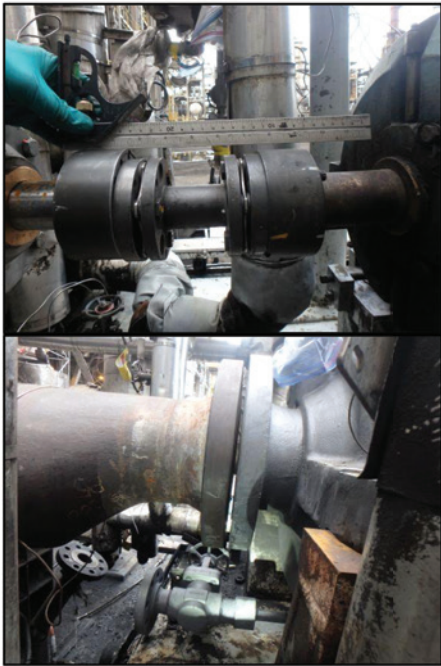
A customer was experiencing difficulties installing a new pump casing, causing start-up delays. See **Figure 5**. The new pump casing had not gone through the proper quality assurance to determine if the pump casing matched the manufactured drawing. Laser scanning is a useful tool for parts that require high accuracy to confirm dimensions before the equipment is sent to the field. This ensures that start-up delays due to fit-up issues are avoided. Following fit-up issues, the new pump casing was laser-scanned to compare dimensions to those of the drawing. Based on the comparisons, several casing dimensions did not meet the tolerances in the drawing (refer to **Figure 6**). The customer was forced to return the old pump casing to service for a limited time while a new one was procured. The client was motivated to find a solution with the existing new pump casing instead of waiting for a new pump casing that had the correct dimensions. A creative solution was found by leveraging a model of the old pump casing generated through a previous laser scan. From comparing

**Figure 5.** Note the offset between the coupling and line on the top image and the suction piping and line on the bottom image.

the laser scan of the old pump casing to the new pump casing, modifications could easily be made to the supports and pump to accommodate the new pump casing. At the next scheduled maintenance outage, the old pump casing was replaced with the new one once the supports and pump had been altered slightly. This illustrates the importance that historical laser scans have. They can be accessed at any time to help solve problems many years down the road.

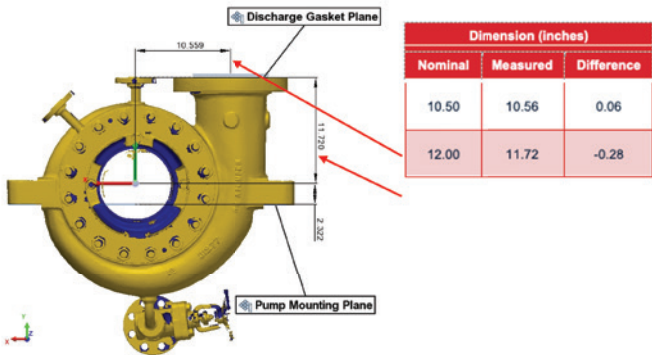
**Figure 6.** Note differences between drawing and laser measurements.

Typically, 2D drawings are used to manufacture new parts. However, rotating equipment requires accurate dimensions for fit-up and to minimize vibrations. In this instance, laser scans identified dimensional inaccuracies, facilitated fit-up, and prevented further downtime.

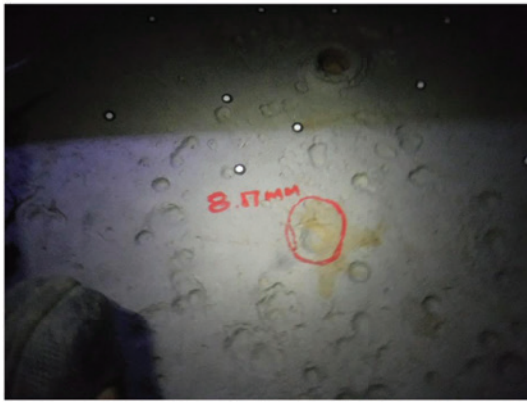
A 5-foot diameter, 15-foot-long horizontal vessel had pits along the shell bottom ID (4 – 8 o'clock position). The bottom outside surface of the insulated corrosive service vessel was not accessible

Figure 7. Vessel pitting morphology.

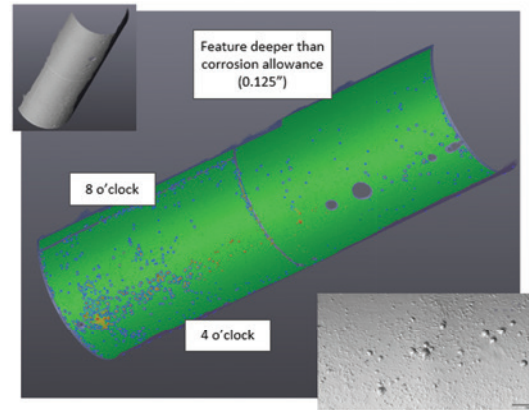
Figure 8. Overview of pitting.

due to limited access and insulation. Its corrosion allowance was 0.125 inch, and its nominal thickness was 0.500 inch. Due to extensive pitting and cratering, this vessel was routinely taken out of service to assess and repair the pitting. Previous pit gauge inspections had taken several days and had challenges identifying individual pits and evaluating pit depths. **Figure 7** shows some of the vessel pits. This illustrates the challenges of doing extensive pit gauging. Repeatability and accuracy are a concern, especially after doing it for several days. The laser scan took six hours and identified about 700 pits, resulting in below corrosion allowance thickness values. See **Figure 8**.

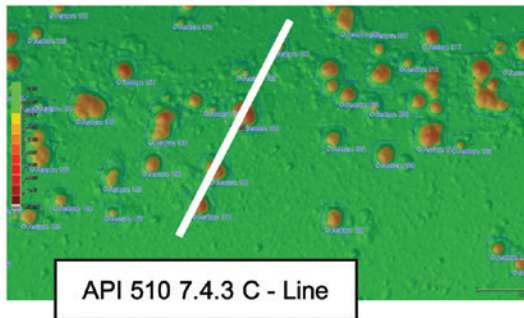
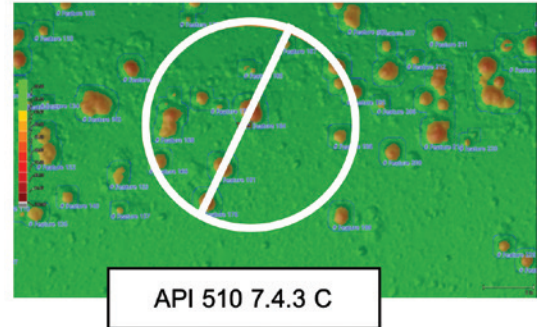
API 510 7.4.3 - Evaluation of Scattered Pits							
Feature identification	Max. depth axial pos.	Max. depth circ. pos.	Max. depth	Length	Width	API 510 7.4.3	
	In	In	In	In	In	b) Area	c) Line
Feature 001	0.256	107.734	0.160	0.433	0.395	Pass	Pass
Feature 002	1.083	123.025	0.254	1.378	0.711	Pass	Pass
Feature 003	0.217	95.011	0.168	0.315	0.356	Fail	Pass
Feature 004	0.217	97.737	0.193	0.433	0.830	Fail	Pass
Feature 005	0.295	87.029	0.271	1.024	1.146	Fail	Fail

Figure 9. Vessel pitting laser data table summarizing the use of API 510 Clauses 7.4.3 b) and c).

Then, to determine what repairs were needed and expedite the repairs, the laser scans were evaluated using the API 510 Clauses 7.4.3 b) and c) [4]. See **Figure 9**. These clauses state:

- “The total area of pitting deeper than the corrosion allowance does not exceed 7 in.<sup>2</sup> within any 8 in. diameter circle.

- The sum of the pit diameters whose depth exceeds the corrosion allowance along any straight 8 in. line does not exceed 2 in..”

This evaluation would have been impracticable on the manual pit gauge data. From the 3D models, the pitting requiring repairs to satisfy the API 510 criteria was more easily identified. From the 700 pits, the anomalies requiring repairs were reduced to 270. The downtime initially planned for 10 – 14 days was reduced to 5 days. As well, additional repairs were planned for the next scheduled maintenance period. Laser scanning was the right tool for this evaluation. Manually applying the criteria from API 510 Clauses 7.4.3 b) and c) accurately would be extremely difficult given the widespread pitting.

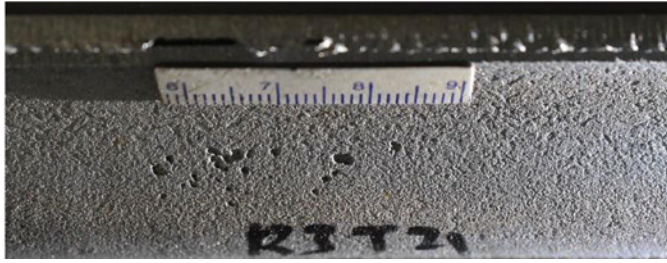
**Figure 10.** Tube after media blasting. Note the pits are narrow and isolated.

The owner of the heat exchangers requested visual examinations and laser scans of split tubes—they needed to determine what kind of damage was occurring in the tubes. The 20-foot-long by 0.083-inch-thick tubes, which were all removed and split, had narrow and isolated pits. See **Figure 10**. The manual pit gauge tips were too wide to fit into certain pits. Also, measuring thickness values reliably in the small tube surfaces was challenging. However, the laser software pit gauges can be adjusted to various diameters for repeatable and accurate results. Also, data such as the axial length, circumferential width, axial position, pit diameter, and pit depth are mapped, as shown in **Figures 11** and **12**.

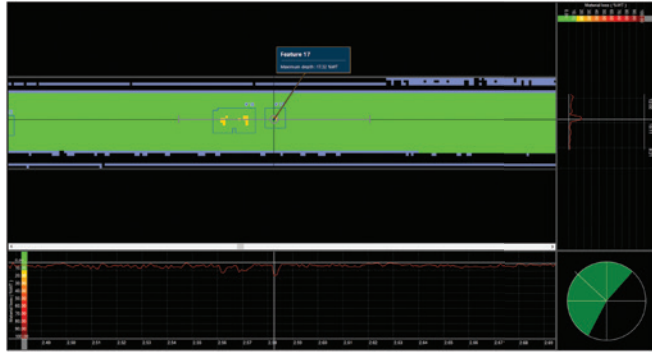
**Figure 11.** A laser scan of the pits shown in Figure 10.

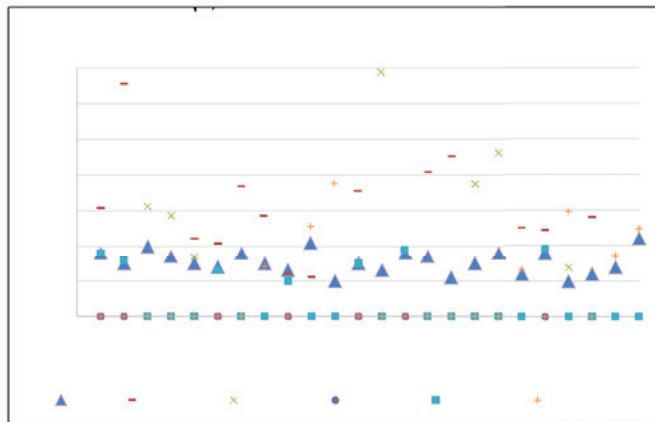
**Figure 12.** Laser versus Vendor RFT Calls

Statistical analyses of the probability of sizing (POS) and probability of detection (POD) were performed to compare the vendors. Most vendors had trade-offs between POD and POS. For example, Vendor 4 could assess the size of eight features within  $\pm 3\%$  WT but did not detect the remaining 18 features. There was no clear winner regarding which vendor was the most accurate.

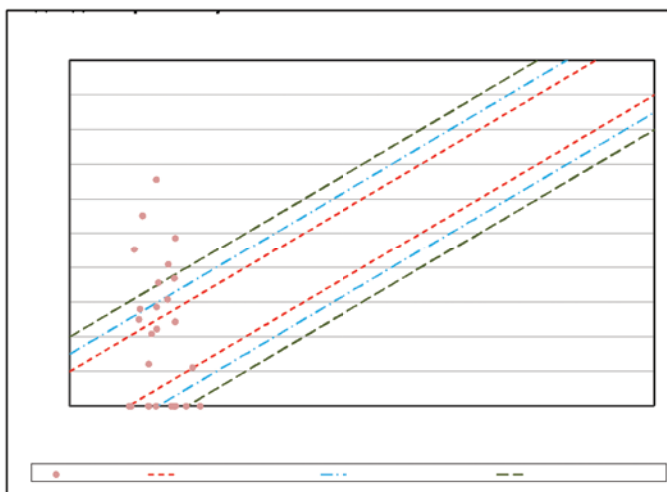
**Figure 13.** The RFT wall thickness values plotted versus the laser data.

For example, the data from one of the vendors is discussed in detail. The RFT wall thickness values were plotted versus the laser data. See **Figure 13**. The X-axis shows many internal pits the laser identified that the RFT did not detect. Also, RFT identified many pits as deeper than 20%, whereas the laser only identified pits shallower than 23%. Based on the RFT data, many tubes would have required plugging, reducing the exchanger's efficiency; however, laser data found plugging not to be required on many of the tubes.

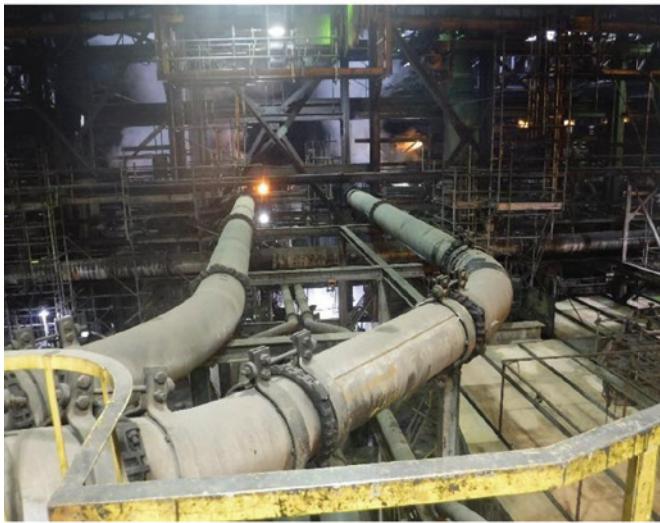
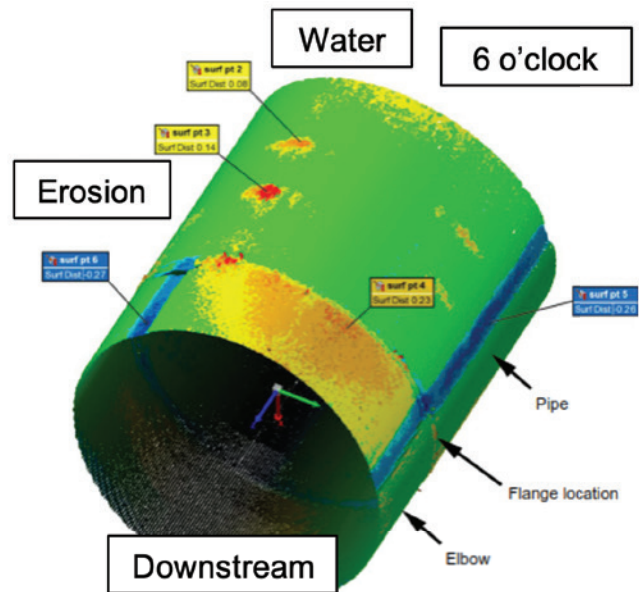
This application is still in development. A customer inquired about a more economical process for inspecting their urethane/rubber-lined piping. Heavy erosion from the oil sands resulted in a “dished area” downstream of the flange connections; the losses mainly resulted from misalignment during fit-up. There is currently no inspection technique to quantify the remaining internal liner thickness from the exterior, so the lined spools had to be disconnected and lowered to the ground for inspection. Considerable pipe handling was required, often leading this to be the critical path in turnarounds. A robotic technology that can navigate the piping, locate the dished areas, and quantify the remaining wall thickness would be beneficial.

**Figure 14.** Lined piping is shown on the left. The image on the right represents the type of damage.

The damage typically occurs at the 6 o'clock position of the pipe, as shown in **Figure 14**. However, to extend the piping life, the spools are often rotated. Consequently, the damage can be on any side, causing an unusable reference surface. Reminder: laser scanning is a line-of-sight-based technology that requires a reference surface. A reliable reference without losses is needed for laser scanning to obtain information. When the reference has been rotated several times, and the previous damage is unknown, a reference cannot be used. Therefore, the strategy remains to use laser scanning to determine if dished areas are present at a particular flange location. From there, quantitative, time-consuming measurements will be performed. The objective of the laser scan will be to ensure that dished areas are not missed. Unlike all the previous examples, the laser scan is not a quantitative tool in this case but rather a qualitative screening tool.
