Looking under the covers for Corrosion Under Insulation - RTR

Often insulation is stripped to assess where corrosion under insulation (CUI) has developed. Damaged insulation is taken as a sign of potential CUI, but this is not always correct. However, insulation removal can be time consuming and labour intensive. Today's NDT tools can help us hone in on suspect areas without stripping insulation. Specifically, the portable real-time X-ray digital detector array (DDA) system referred to as real time radiography (RTR) helps to look under the insulation covers. With RTR we obtain an electronic rather than a film image almost instantly (in real time) as we expose the surfaces under examination to radiation.

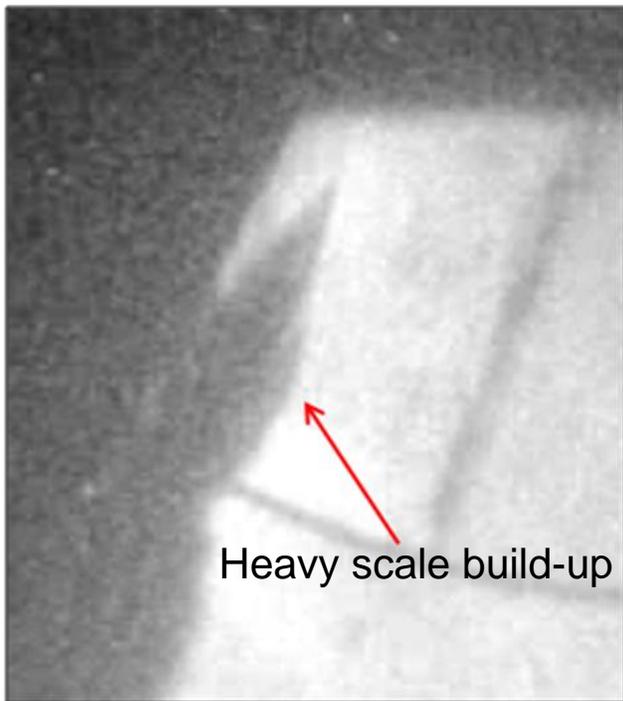
The RTR image below shows heavy scale build up on the pipe. The RTR is followed by computed radiography (CR to the right) or other forms of RT to assess the remaining thickness without removing insulation. This is of particular importance with asbestos insulation.

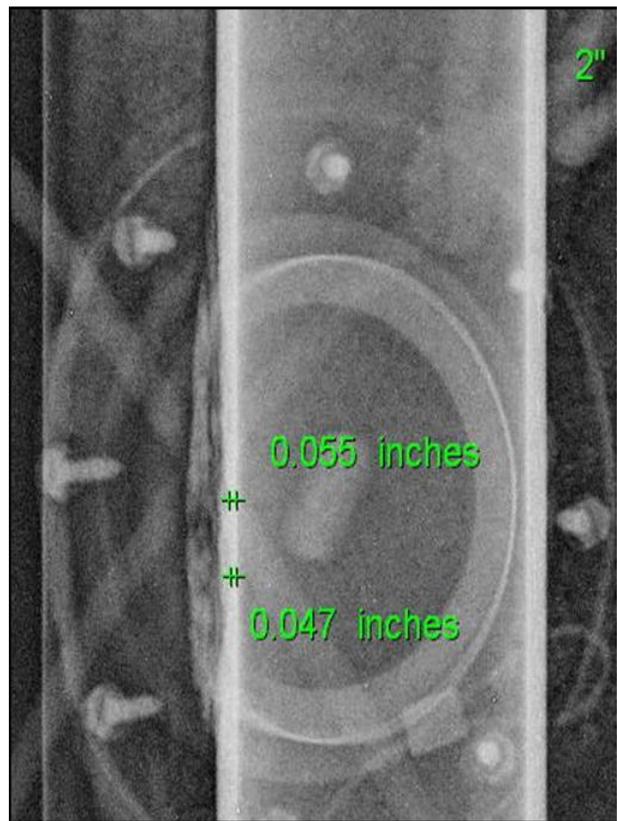
The pipe remaining thickness was below the minimum required thickness for the service. The insulation was removed and the damage shown in the photographs below was identified.

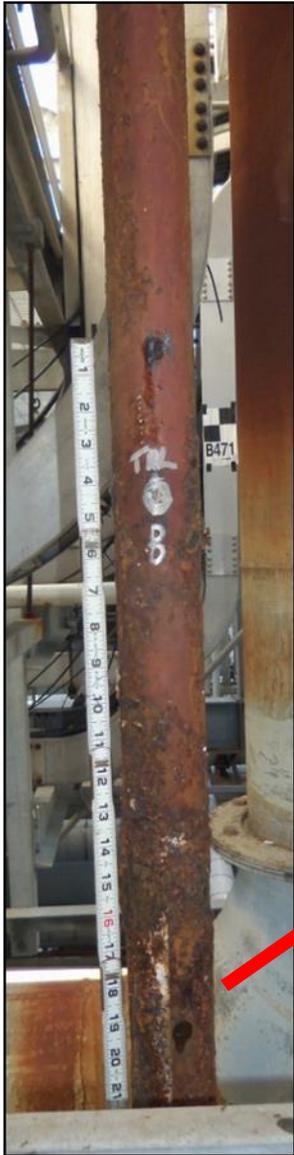
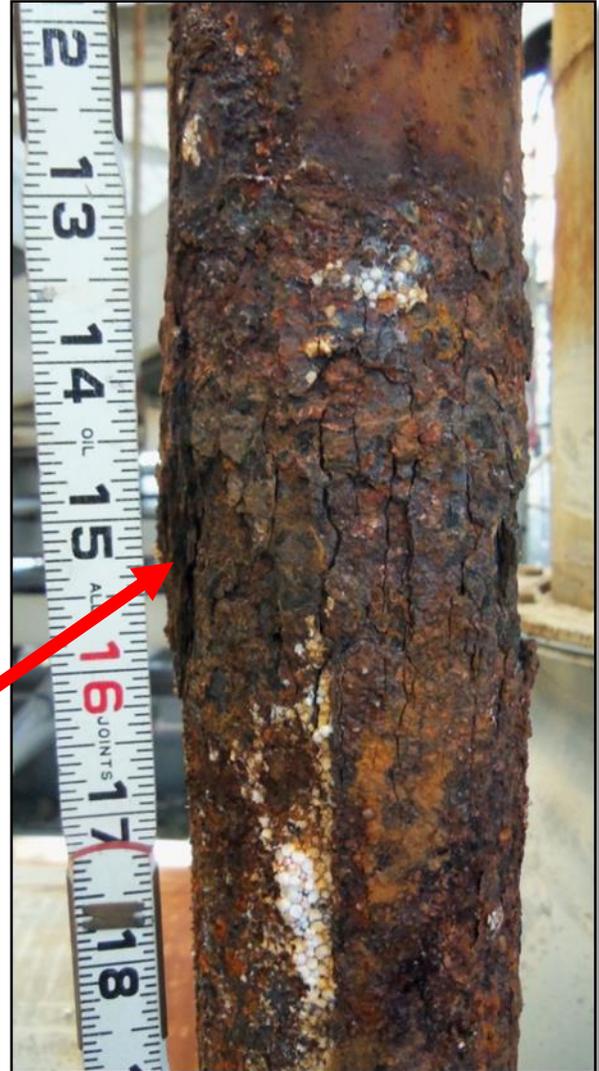
Pipe shown in the CR image in the previous page after stripping insulation. As the CR showed, losses were extensive.
