## Guided Wave Testing Case Study 5 Inspection of Pipelines for Corrosion Under Insulation

### Job Details

- 8" Jet fuel line
- Painted pipe surface
- Mineral wool insulation
- Pipe resting on simple supports

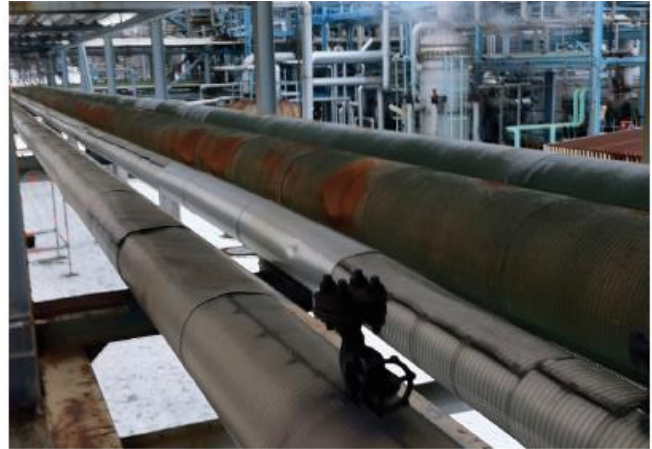
An overview of the 8" insulated pipe resting on the pipe rack.

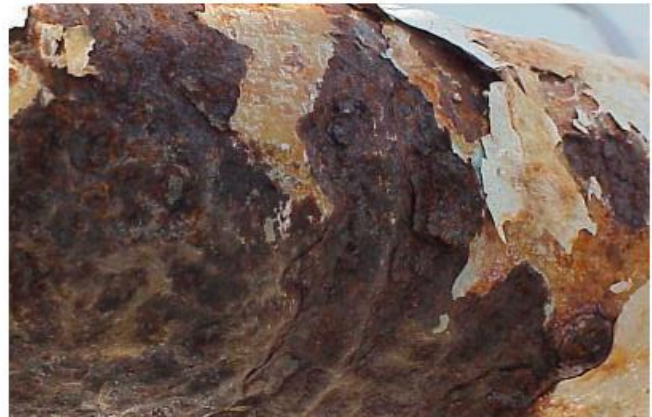
- An area of corrosion was positively identified under insulation
- Removal of insulation confirmed the presence of heavy corrosion allowing direct examination

An area of severe corrosion on the 8" insulated pipe.
