Guided Wave Testing Case Study 4 Inspection of Pipelines at Soil to Air Interface

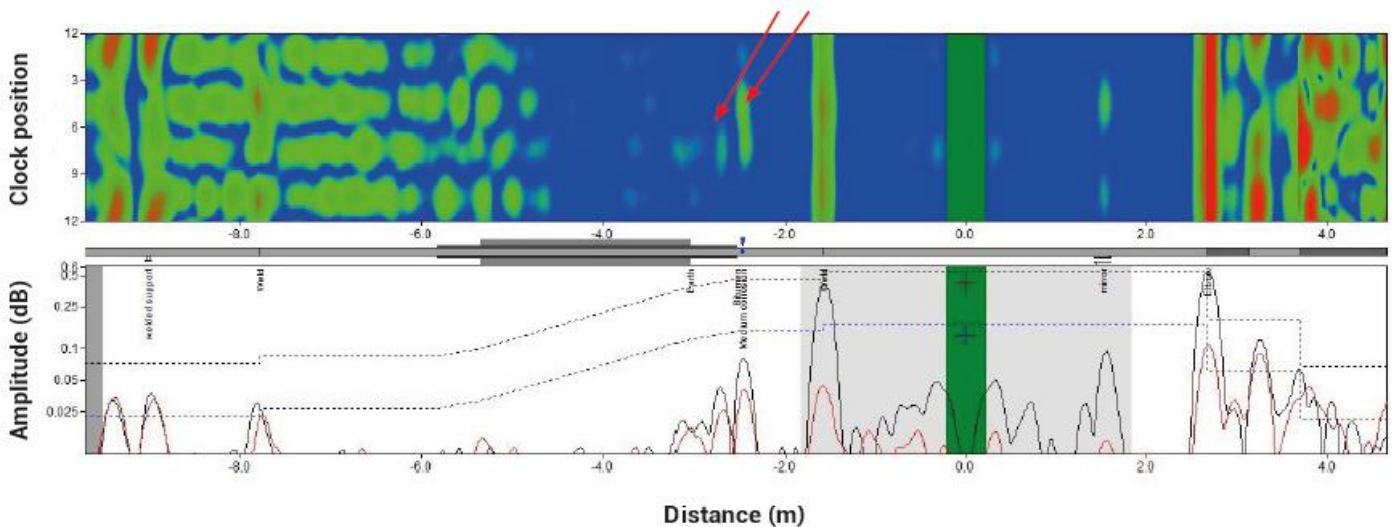
- Soil/air interface and buried section inspected
- Medium (Category 2) corrosion identified at the entrance location
- Defect axial position and circumferential orientation highlighted for follow up and repair

Corrosion patch detected at the entrance location.
