Guided Wave Testing Case Study 7 Defects in Elbows

- 16" Crude Oil line
- Tight 1D elbows

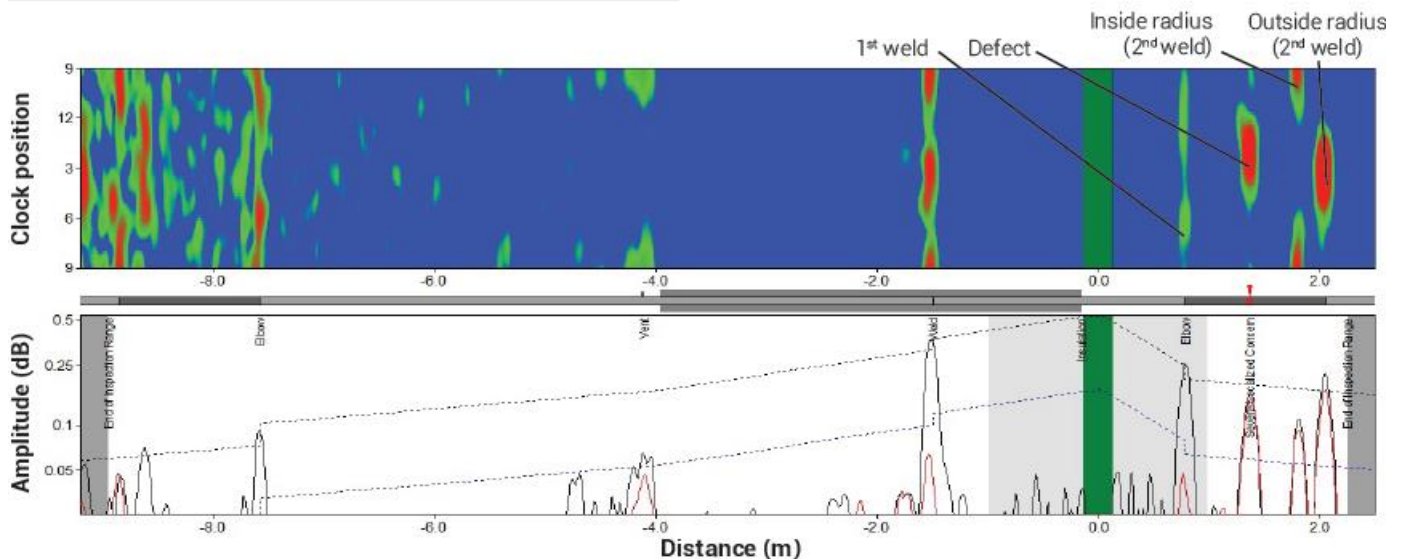
- Defect located in one of the two elbows within the test range.
- The defect is circumferentially aligned with the outer radius where the erosion type defects are commonly found.
- UT confirms the elbow defect has a 65% wall loss.
